(NASA-TM-X-70381) EVALUATION OF GROUND
CHARACTERIZATION SAMPLES MCN-2 AND MCN-3,
SECTION 1 (NASA) 56 p HC \$6.00 CSCL 13H

SECTION I. EVALUATION OF GROUND CHARACTERIZATION
SAMPLES MCN-2 AND MCN-3

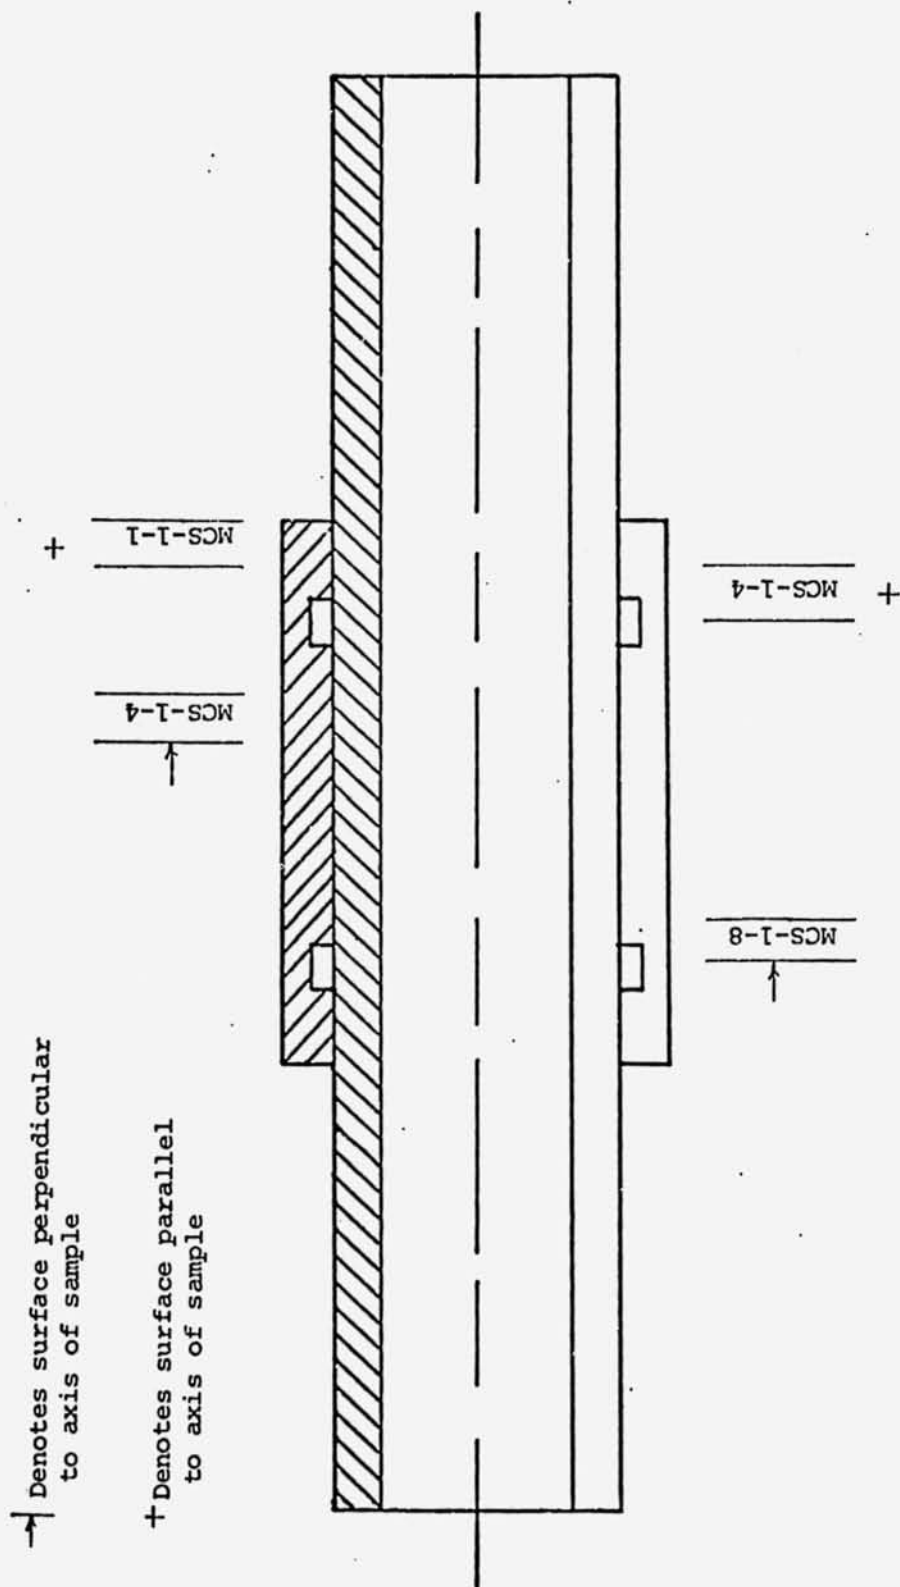
FIGURE II-2. SURFACES EXAMINED DURING METALLOGRAPHIC EVALUATION (MCS-1)

Four sections representing areas where significant joint features might be evident were examined. The designation and approximate location of each section are shown in Figure II-2. Sections MCS-1-1 and MCS-1-2 were cut and mounted to permit examination of the joint surfaces parallel to the longitudinal axis of the sample. Sections MCS-1-4 and MCS-1-8 were mounted to show the entire circumferential joint between the tube and the sleeve, i.e., the surface perpendicular to the longitudinal axis of the sample. The metallographic specimens were examined in the unetched and etched condition.

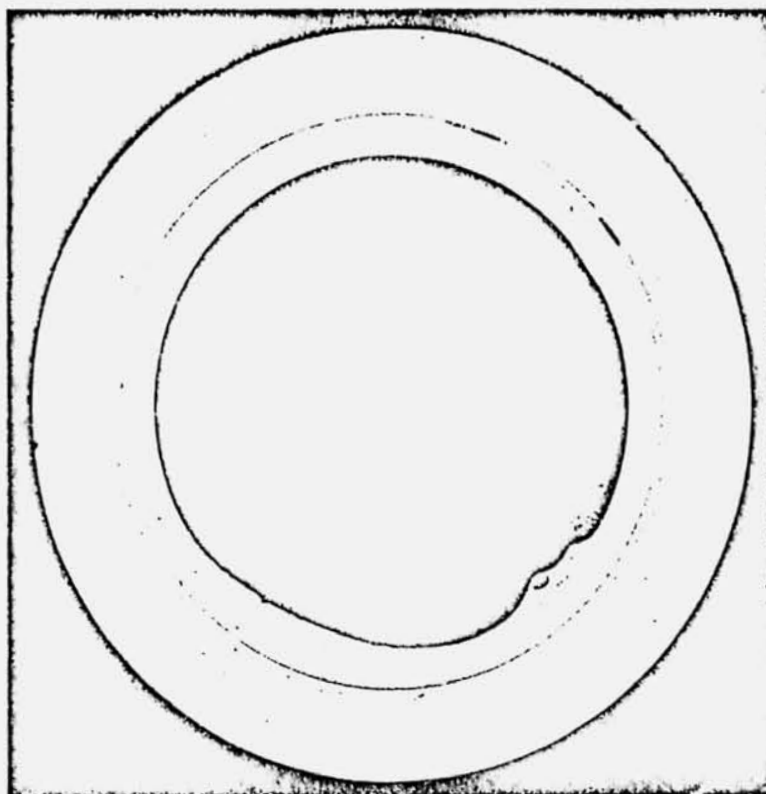
FIGURE II-6b. SECTION MCS-1-2

The microstructure of an area of accumulated filler metal is shown in the unetched condition at 250X and 500X in Figures II-6a and II-6b. Reaction between the base metal and molten filler metal at the interface is clearly evident. The microstructure of the bulk filler metal is quite complex, consisting of products from the base metal-filler metal reaction and possibly some silver-copper eutectic.

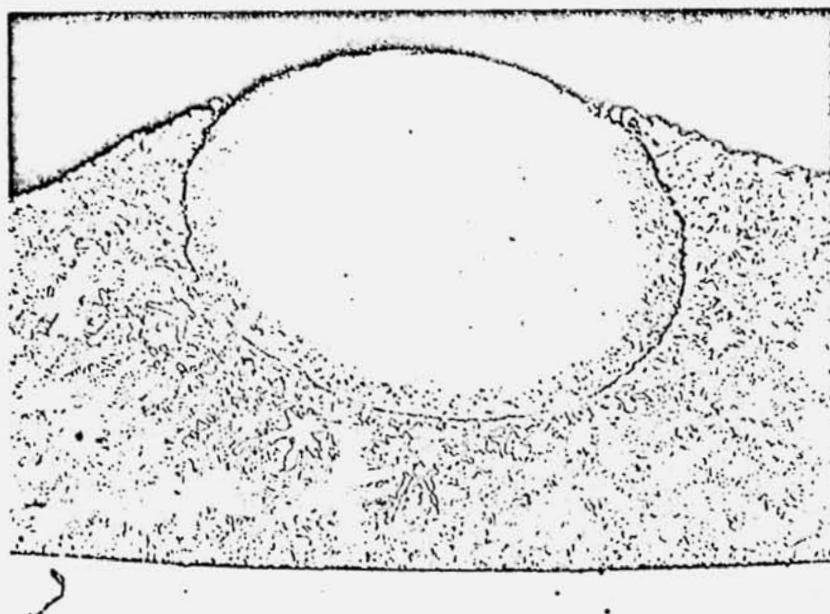
FIGURE II-9. SECTION MCS-1-4

An area of the filler metal accumulated inside the tube is shown at 250X in Figure II-9. The microstructure of this area is somewhat different than that shown in Figure II-6a; a dendritic phase is present in a matrix of filler metal. The amount of reaction between the base metal and molten filler metal is comparable in both areas.

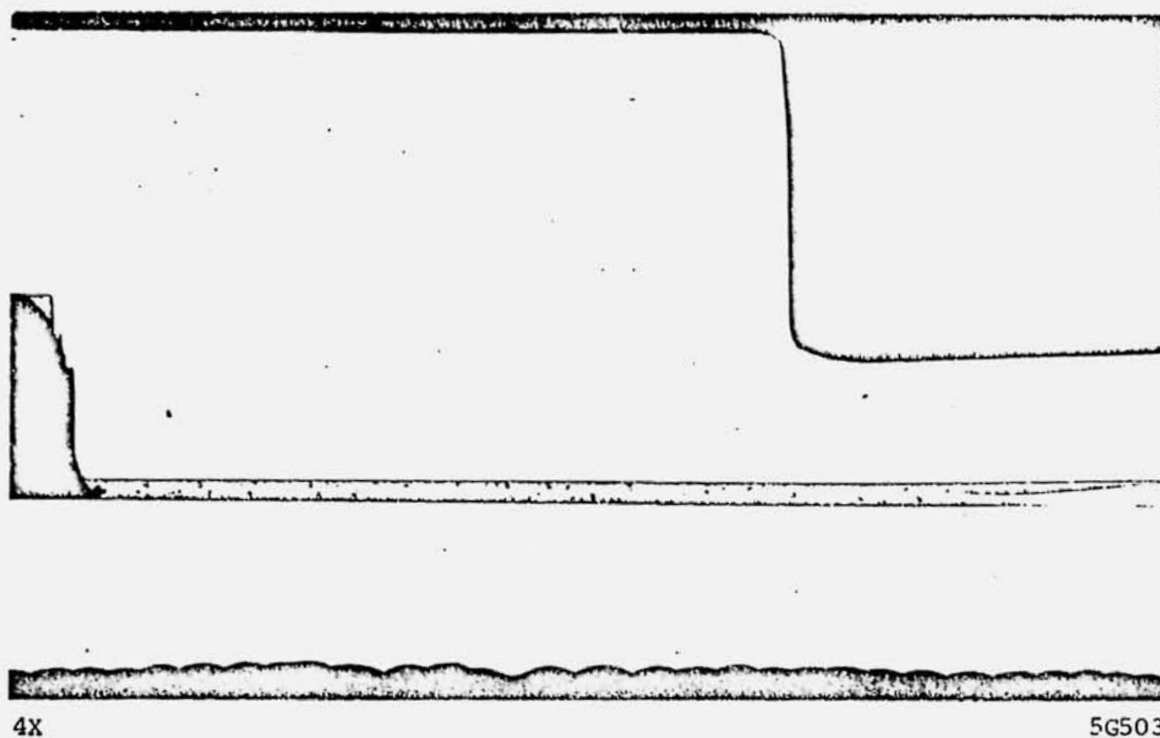
FIGURE II-16. SECTION MCS-2-7

The circumferential joint between the tube and sleeve is shown at 4X in Figure II-16. Excellent flow of the filler metal during brazing occurred. The joint is completely filled; there were a few small isolated voids of little significance. Filler metal flowed through the slits in the center of the tube and accumulated in the bottom inside of the tube. As it did so, it brazed the thermocouple to the inside of the tube. The joint microstructure and the microstructure of the accumulated filler metal is similar to those observed previously.

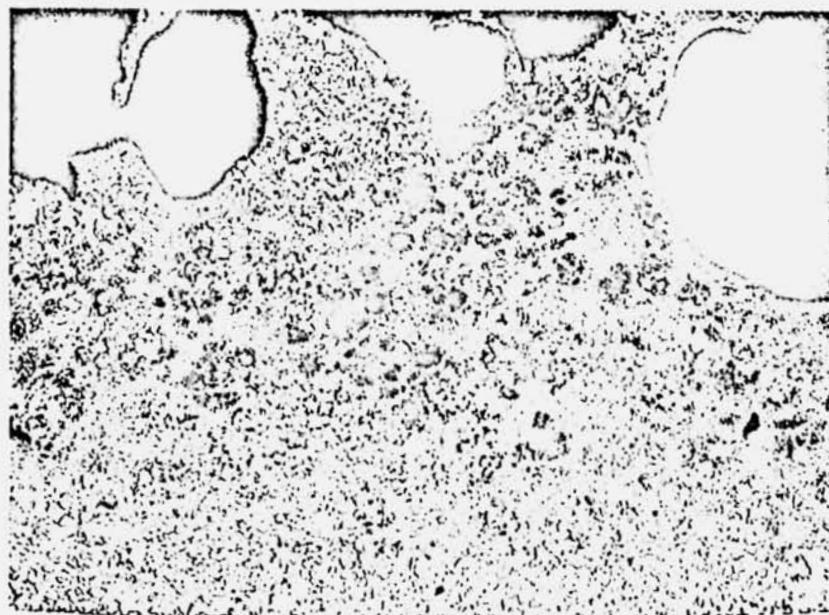
FIGURE II-19a. SECTION MCS-3-3

A section through the right-hand ring groove is shown at 4X in Figure II-19a. The ring groove is void; however, a thin film of filler metal was present on its surfaces. The surface roughness of the filler metal that accumulated inside the tube during brazing is clearly evident. An area of accumulated filler metal is shown at 100X in Figure II-19b. Voids or pores are present in this area. The microstructure of this area is somewhat different from that observed in similar sections from Samples MCS-1 and MCS-2. Although the maximum brazing temperature for Sample MCS-3 was less than it was for the other two samples, the products of the reaction between the base metal and the molten filler metal appear to be dispersed in larger amounts throughout the microstructure.

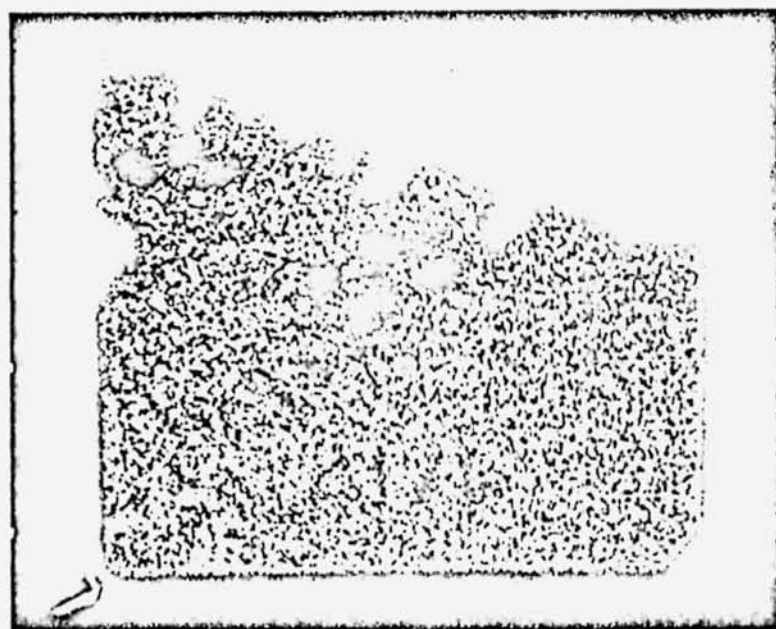
FIGURE II-22. SECTION MCS-2-4

- (1) The phase (A in Figure II-22) along the joint interface that was produced by dissolution of the base metal by the molten filler metal contained 73 percent (or more) copper, some silver (about 6 percent), and a small amount of nickel. Chromium and iron were not detected in this area.
- (2) The composition of the phases labelled B and D in Figure II-22 was almost identical to that of the phase labelled A. These particles resulted from the base metal-filler metal reaction and became detached as dissolution of the base metal progressed.
- (3) The light areas (C in Figure II-22) are composed of essentially pure silver.
- (4) The presence of nickel, chromium, and iron in the base metal (E in Figure II-22) is indicated by the X-ray images for these elements.
